MSAIJ, 12(2), 2015 [036-045]

Experimental analysis of thermal and thermo-physical behavior of 7Y-PSZ as thermal barrier coating over A336 alloy substrate

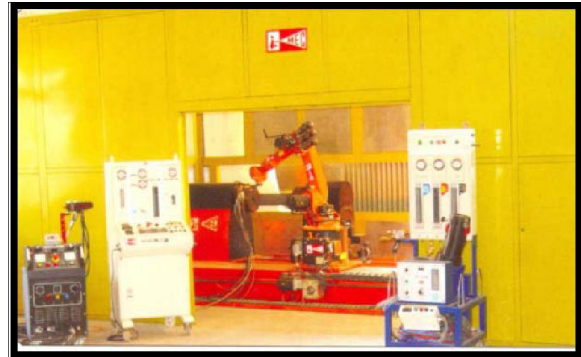
Figure 2 : Plasma spray facility at MECPL, Jodhpur (Rajasthan)

Coating of the ceramic top coat and the intermediate bond coat were provided with the help of plasma spray facility available at Metallizing Equipment Co. Pvt. Ltd. (MECPL), Jodhpur (Rajasthan), India (Figure 2).

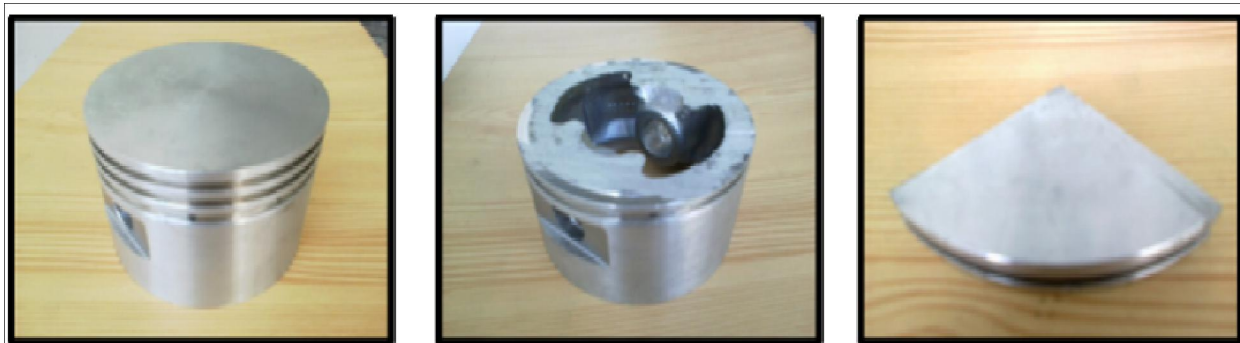
and its top solid disc like portion of thickness about 8 mm was cut out from the remaining part. This disc portion was machined to a throughout uniform thickness of 5 mm and was further cut into four identical quarter parts. Three of these quarter parts were used as substrates in the experimental analysis. Figure 1 shows the picture of actual piston used and a particular specimen machined out from it.

Figure 1 : Flat top surface piston (left); piston after top portion removal (middle) and 5 mm thick quarter portion specimen (right)

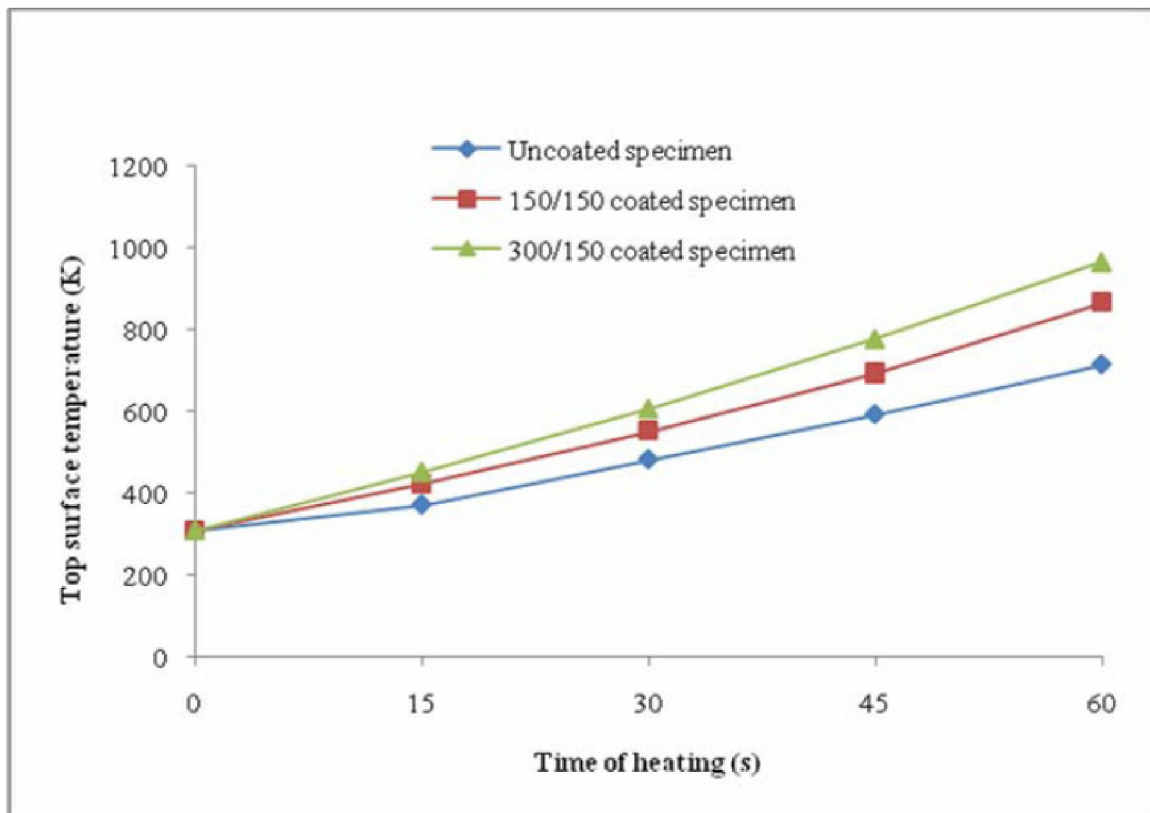
Figure 5 : Effect of Y-PSZ/NiCrAlY TBC on top surface temperature

Figure 5 and Figure 6 show plots of top surface and top substrate (coating/substrate interface) temperature variation within each specimen versus time of heating, respectively.

Observing the slopes of the curves in these figures, it is clear that as compared to uncoated substrate, the coated substrate experiences more increase in the top surface temperature and less increase in the coating/substrate interface temperature during constant flame heating. Further, 300/150 coating was found to behave more effectively in this heat penetration reduction as compared to 150/150 coating. It was calculated from the observed data that after 60s of flame heating and as compared to uncoated specimen, 150/150 coating caused 21.12% increase in top surface temperature and 4.48% decrease in top substrate temperature whereas 300/150 coating resulted into an increase of 35.24% in the top sur-

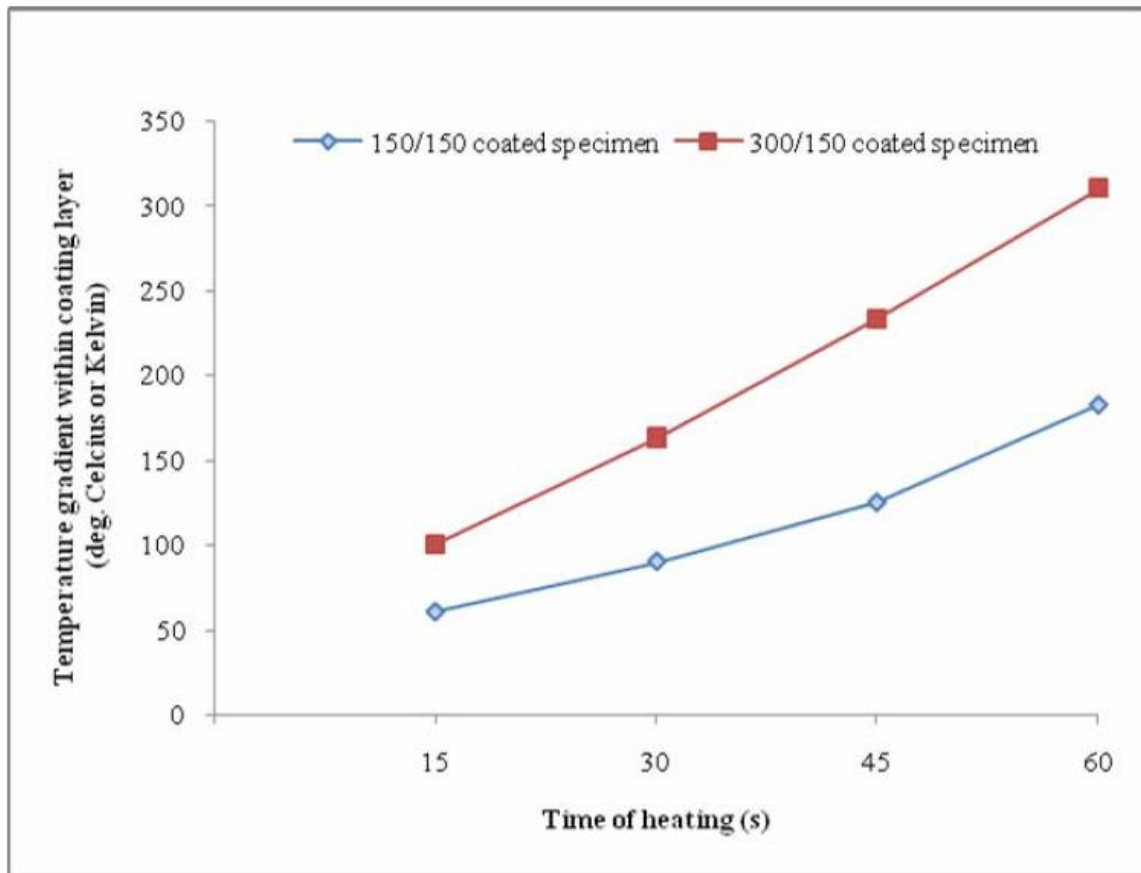
Figure 7 shows change in the temperature gradient within coating layer with respect to time of heating for two different coating thicknesses. The figure shows that as the time of unsteady state heating increases, the temperature drop within the TBC layer also increases. Thicker coating carries more gradient than the thinner one and rate of increase of thermal gradient across TBC layer is also more in case of thick 300/150 coating as compared to 150/150 coating.

Figure 7 : Temperature gradient within coating layer at different time of heating for two different coating thicknesses
