STRUCTURAL HEALTH MONITORING OF THE COMPOSITE PLATE GIRDER IN A CANTILEVERED BUILDING

Key words: Health monitoring, Composite steel plate girder.

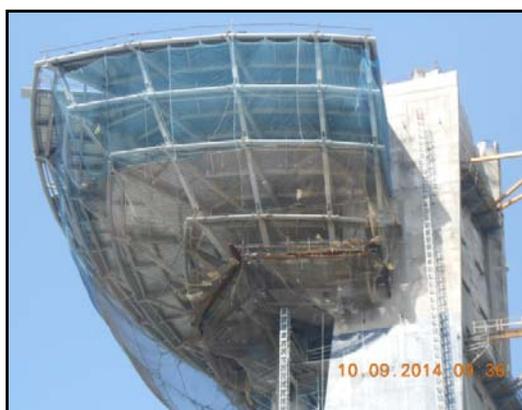
Fig. 1: Field Photo: The observation deck

The signature tower consists of RCC central core and four-floor deck systems which are made up of steel-concrete composite construction. The observation deck is located at 94m above ground level and cantilevering 17 m to 21 m from the center of the core. The floor deck system consists of total 14 numbers of deep plate girders in each floor. The field photo of the observation deck and plan of the deck system are shown in Figs. 1 and 2, respectively the details of the plate girder are shown in Table 1. The yield strength of the steel used for plate girder is 355 N/mm^2 and M40 grade concrete was used for the slab.

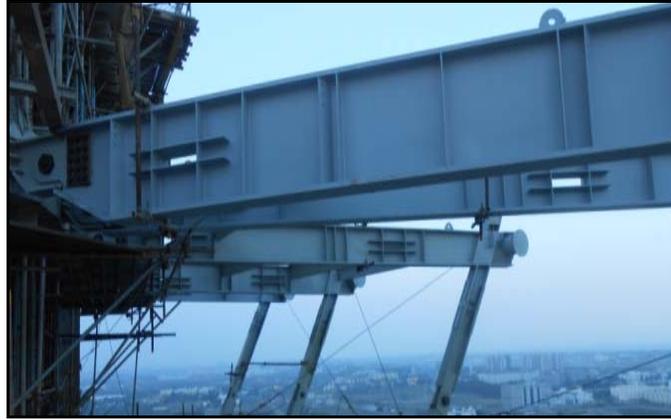
The plate girders in the floor deck system are provided with huge anchorage plates at the end which in turn is encased with the reinforced concrete central core. Fig.3 shows the anchorage system.

Fig. 3: Field photo: Anchorage system at 102 m

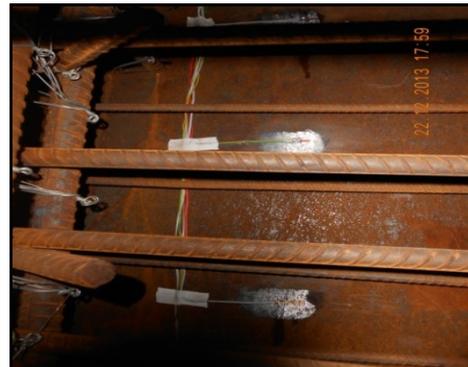
Fig. 5: Field photo: Strain gauges in the girder at site

The steel plate girder is provided with strain gauges across the depth to measure the strain. At level 102 m one strain gauge of strain gauge length 10 mm are fixed in the mid web and two strain gauges of gauge length 20 mm were fixed at the top and bottom of the flanges. Structural steel girder which is embedded with huge anchorage plate at the end of the girder is anticipated to go through maximum stress near the anchorage and therefore the strain gauges were fixed near the anchorage plates. The positions of strain gauges are shown in Fig. 4. Fig. 5 shows the strain gauges in the girder at site. Fig. 6 shows the data logger set-up in the site.

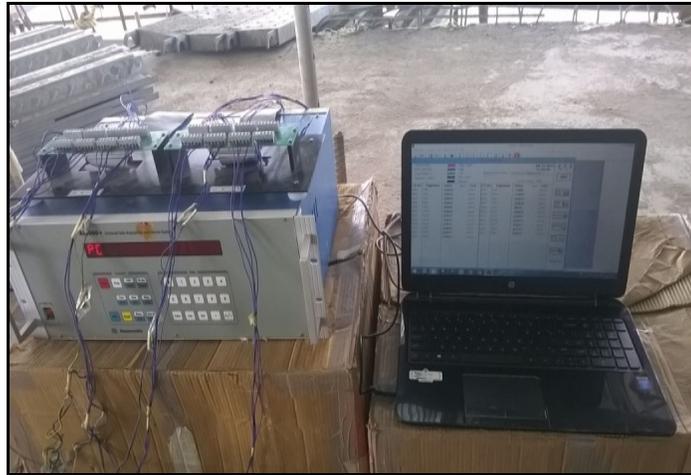
Fig. 6: Field Photo:Data logger set-up
