STRUCTURAL HEALTH MONITORING OF THE COMPOSITE PLATE GIRDER IN A CANTILEVERED BUILDING

ABSTRACT

About the structure

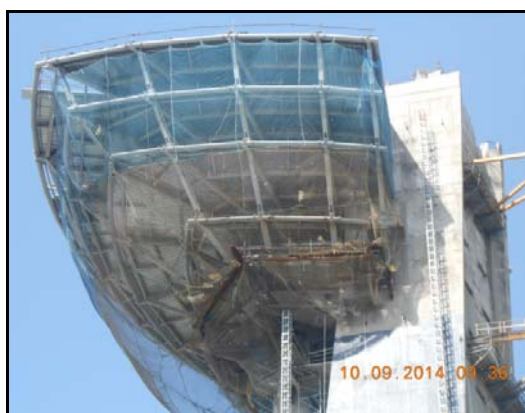
Fig. 1: Field Photo: The observation deck

The signature tower consists of RCC central core and four-floor deck systems which are made up of steel-concrete composite construction. The observation deck is located at 94m above ground level and cantilevering 17 m to 21 m from the center of the core. The floor deck system consists of total 14 numbers of deep plate girders in each floor. The field photo of the observation deck and plan of the deck system are shown in Figs. 1 and 2, respectively the details of the plate girder are shown in Table 1. The yield strength of the steel used for plate girder is 355 N/mm^2 and M40 grade concrete was used for the slab.

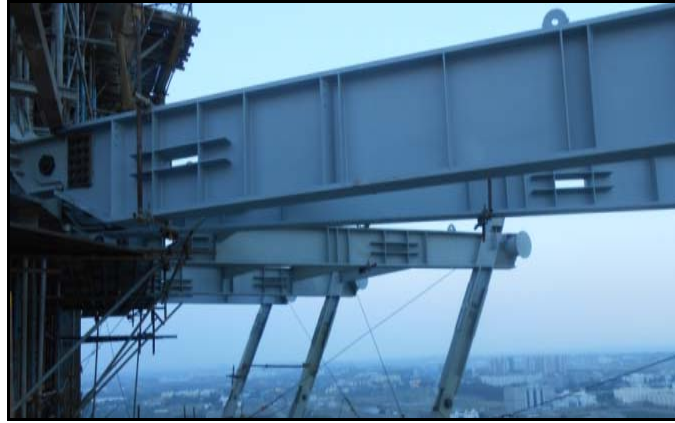
The plate girders in the floor deck system are provided with huge anchorage plates at the end which in turn is encased with the reinforced concrete central core. Fig.3 shows the anchorage system.

Fig. 3: Field photo: Anchorage system at 102 m

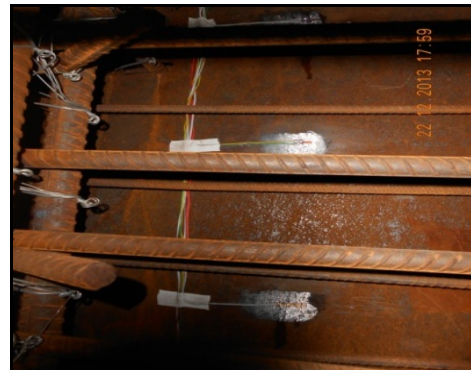
Fig. 5: Field photo: Strain gauges in the girder at site

The steel plate girder is provided with strain gauges across the depth to measure the strain. At level 102 m one strain gauge of strain gauge length 10 mm are fixed in the mid web and two strain gauges of gauge length 20 mm were fixed at the top and bottom of the flanges. Structural steel girder which is embedded with huge anchorage plate at the end of the girder is anticipated to go through maximum stress near the anchorage and therefore the strain gauges were fixed near the anchorage plates. The positions of strain gauges are shown in Fig. 4. Fig. 5 shows the strain gauges in the girder at site. Fig. 6 shows the data logger set-up in the site.

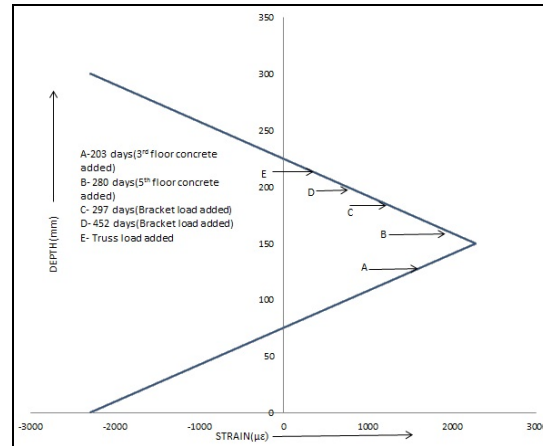
The strain measurements obtained using strain gauges in the Girders PG 2, PG 4 and PG 6 are plotted. Fig. 7(a), 7(b) and 7(c) show the distribution of the horizontal strains in the flanges and in the web along the depth of the girder for the girders PG2, PG4, PG6.

Fig. 7(b): Strain variations along the depth(PG4)

stage of construction and it is in tension after 280 days. But the top flange is always under tension. In the girder PG4 the top and bottom flanges are in tension while the middle flange is in compression. In the girder PG6, the maximum tension occurs at the top and bottom flanges. The web portion of girder PG6 is also under tension.

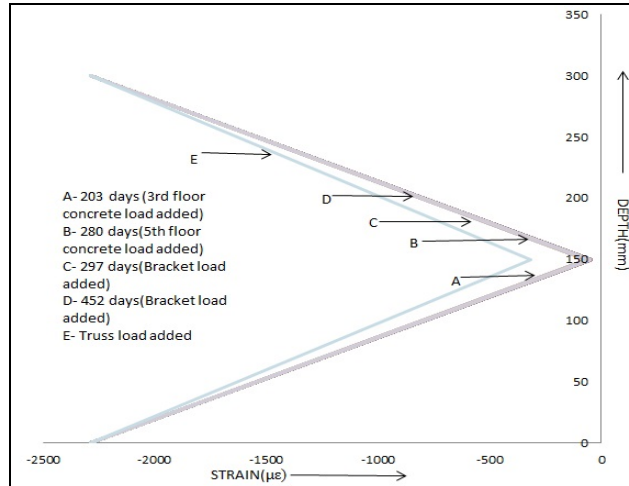
Fig. 7(c): Strain variations along the depth (PG6)

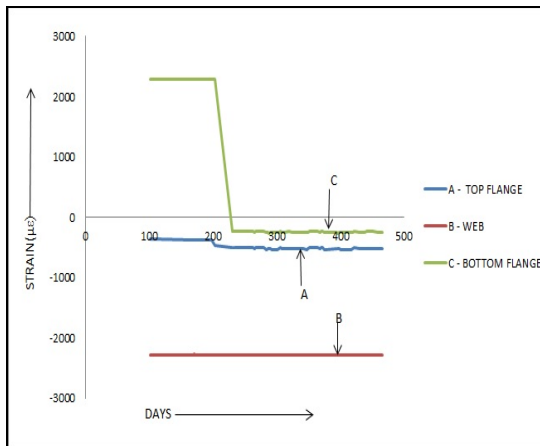
In Fig. 8(a), 8(b) and 8(c) show the strain measured on different days during the construction phase for the girder PG2, PG4, PG6.

Fig. 8(a): Strains measured in the girder during construction (PG2)
