Physico-Chemical Analysis of Groundwater Pollution in Cuddalore District, Tamil Nadu, India

Ganesh Kumar G*, Mohammed Ismudeen AR and Natarajan V

Department of Chemical Engineering, Adhiparasakthi Engineering College, Melmaruvathur-603319, Tamil Nadu, India

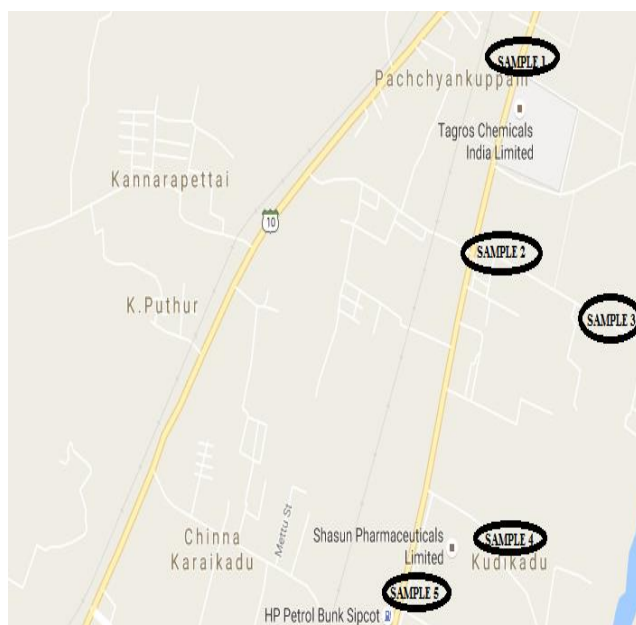
FIG. 2. Location of areas in Cuddalore district.

Cuddalore district is located approximately 23 kilometers from Puducherry. During pre-monsoon seasons (August 2016-December 2016), five samples were taken from five different places every month (FIG. 1). Cuddalore district is located at latitude of 11°45' N, longitude of 79°45' E and altitude of 6 meters (20 feet). This district is famous for Shiva and Vaishnava temples (TABLE 1). These samples are collected in small polythene bottles of 200 ml and cleaned by acid water, followed by rinsing with distilled water. Samples were analyzed to determine pH, total dissolved solid (TDS), electrical conductivity (EC), chlorides, hardness test in the chemistry laboratory (FIG. 2).
